**DELAWARE & HUDSON RAILROAD**  
North Creek Yard / North End c.1900

Based on Adirondack Rwy. Atlas from 1891, 1927 Sanborn map and photos.  
Drawn by Jon Patton, 1/24/08, revised 12/26/08

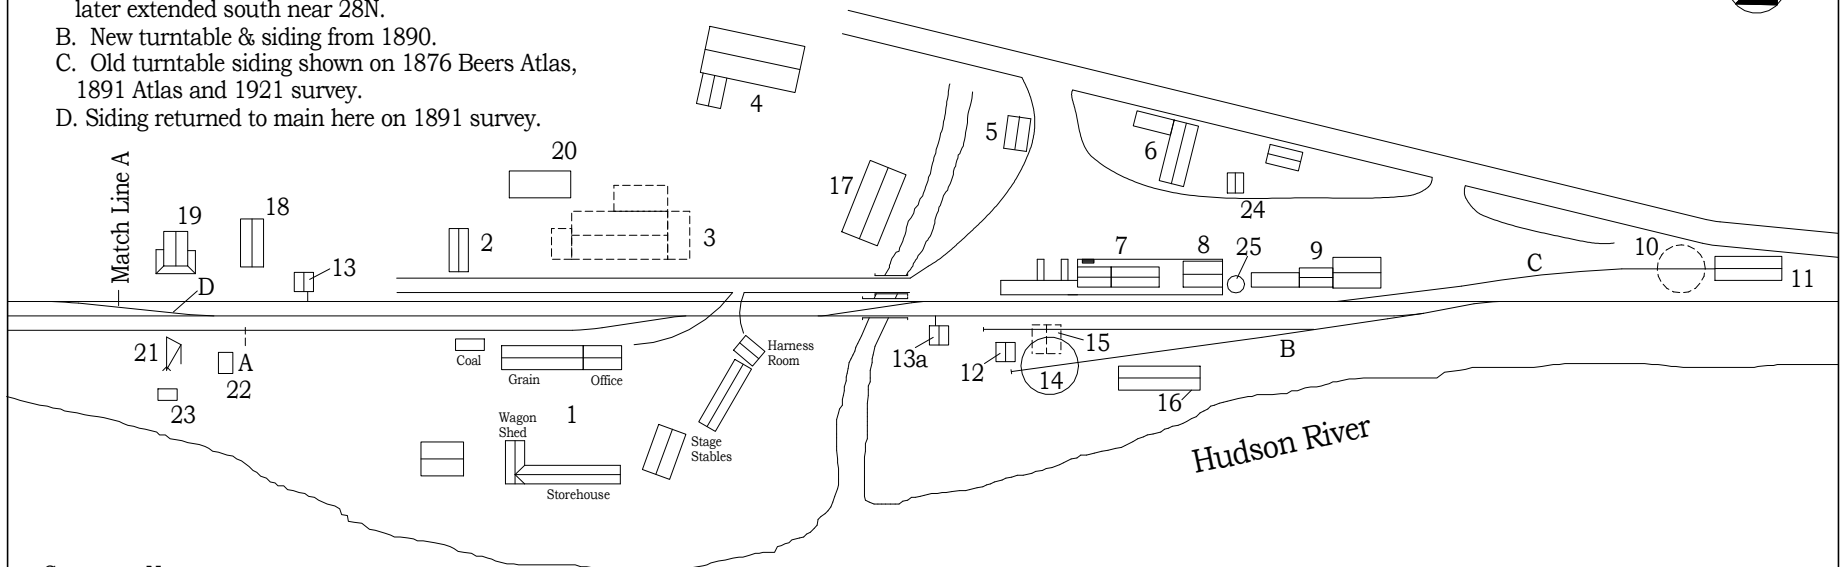
Scale: 1" = 200'

- A. End of 450' siding from 1870's for Durant buildings, later extended south near 28N.
- B. New turntable & siding from 1890.
- C. Old turntable siding shown on 1876 Beers Atlas, 1891 Atlas and 1921 survey.
- D. Siding returned to main here on 1891 survey.

1. The original buildings were built by Durant then changed hands numerous times until W. R. Waddell bought them for a stage line and store in 1897. Four original buildings still exist.\*

2. Small building in c.1920 photo.
3. Durant sawmill from 1870's; gone by 1891 Atlas.
4. Hotel stable torn down in early 1900's.
5. Small shed in 1930's photo, part of blacksmith & wagon shop in 1912.

6. Simon Brown's Carriage & Blacksmith shop, built in 1896, gone by 1912 Sanborn map.
7. Station built in 1872 or 73 with porch added later. Platforms removed in 1938.\*

8. Freight building from 1870's, replaced in 1903.\*
9. F.W. Smith store houses on 1891 Atlas.
10. Old turntable on 1876 Atlas, probably removed in 1890 when new one was built.

11. Engine house on 1876 and 1891 Atlas; burned in 1915.
12. Ice house on 1891 Atlas; removed in 1940.
13. Tool house c.1900 and moved to 13a after 1914 and before 1918.

- 13a. Tool house in 1918 photo. Turned 90 degrees and north end added on after 1933.\*
14. Turntable built in 1890 and replaced in 1944.
15. Water tower in c.1880 photo but not on 1891 Atlas.

16. Unmarked 25'x85' building on 1891 Atlas and in c.1895 photo, one story, gone by 1912.

17. Stable shown on 1913 survey and 1914 photo; gone before 1927, listed in 1912 as Contractor's Storage.
  18. Barn in 1914 photo; gone by 1939.
  19. House in 1914 photo; gone by 1939.
  20. F. Kelly Livery shown on 1913 & 1921 surveys.
  21. Crane for loading or unloading cars. Has bucket mounted on it in 1913 photo for loading ore from McIntyre mine; gone by 1939.
  22. Engine house for crane; gone by 1939.
  23. Ore or coal hopper shown in 1913 photo; gone by 1939.
  24. Tassi shoe shop on 1912, 1913 & 1921 surveys.
  25. Water tank on 1912 Sanborn map.
- \*Structures existing in 2008.
